**GEOMORPHIC FIELD EVALUATION
OF SERPENTINITE SOIL BARRENS,
CLEAR CREEK MANAGEMENT AREA (CCMA)**

Prepared For:
U.S. Department of the Interior
Bureau of Land Management
Hollister Resource Area
20 Hamilton Court
Hollister, CA 95023

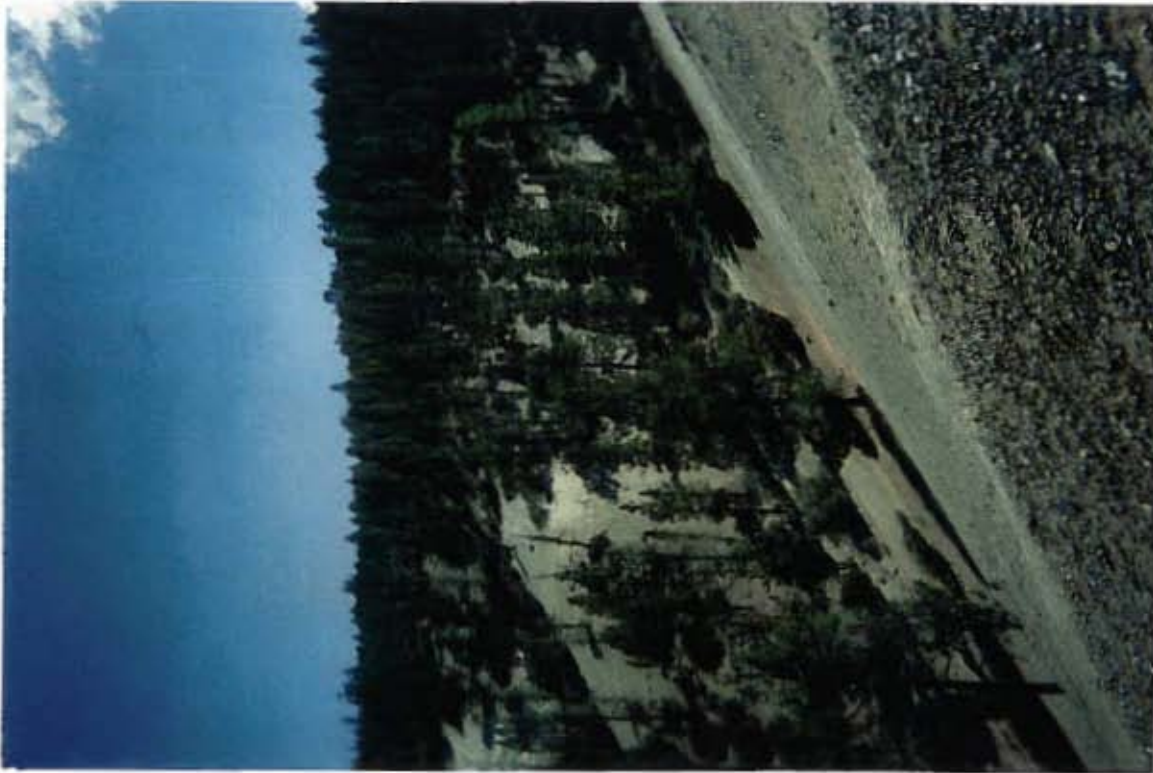
25) Looking SE from CL32A inner gorge ridge line. Undisturbed steep inner gorge slopes.

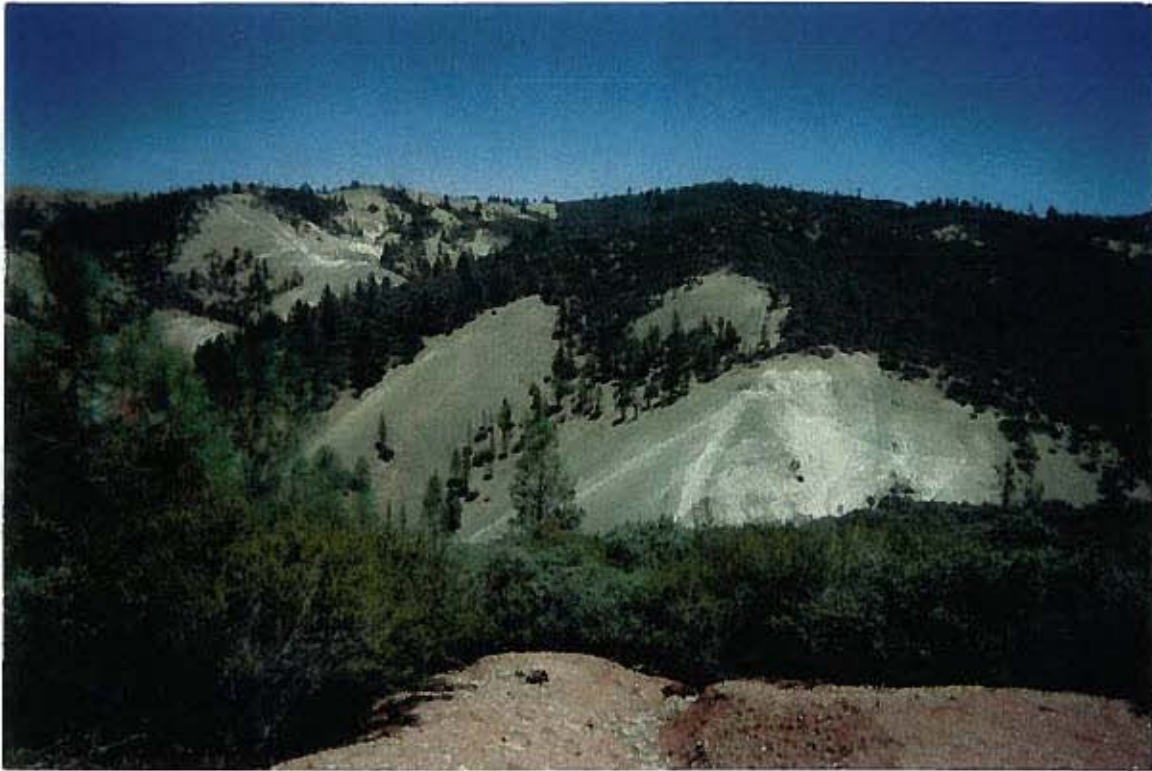
34) Looking NE from CL-33 western ridge. Denuded soils due to play area and hill climb.

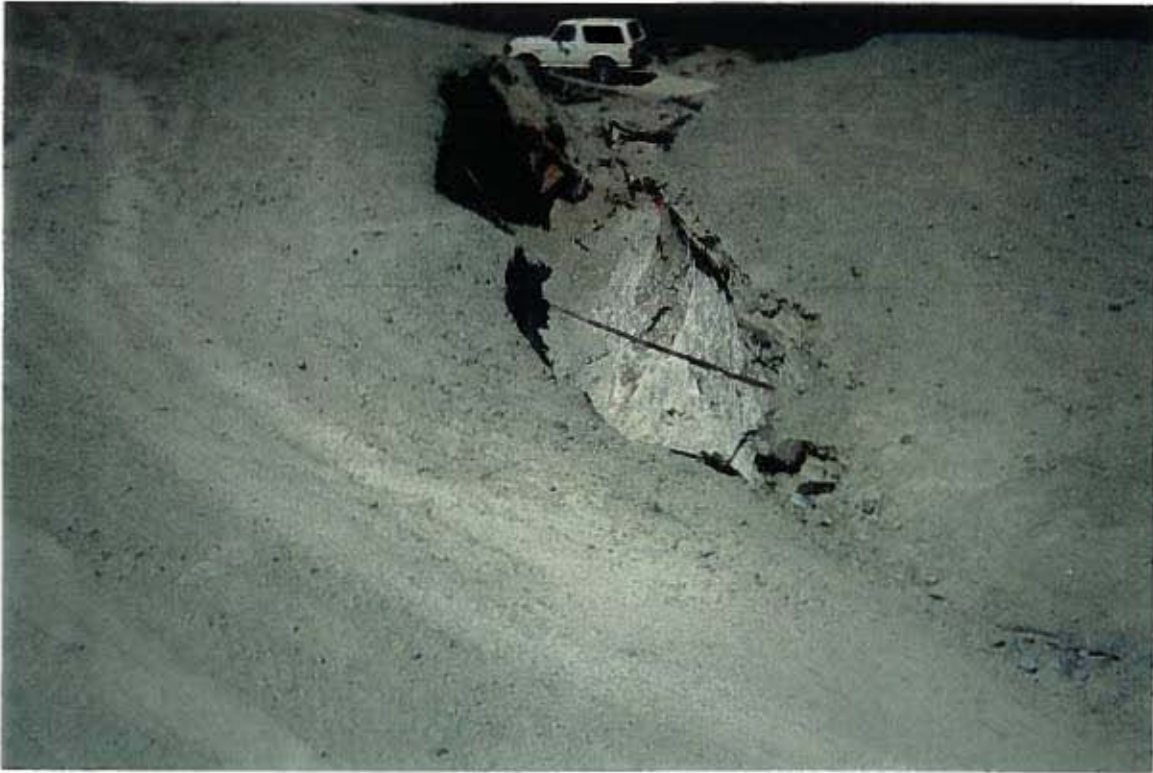
39) Looking N from SC-1. Large gully caused by alteration of natural terrain (road cut).

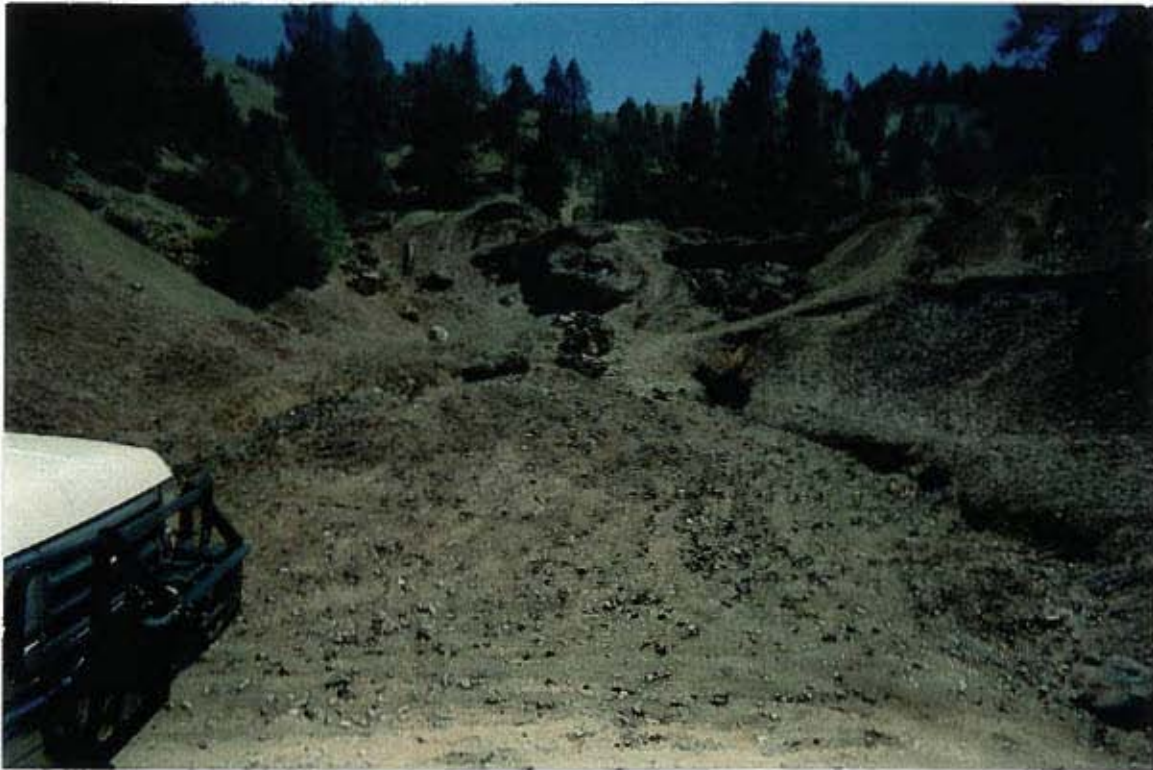
40) Looking S-SW from SC-1. Mining disturbance exhibiting severe erosional features.

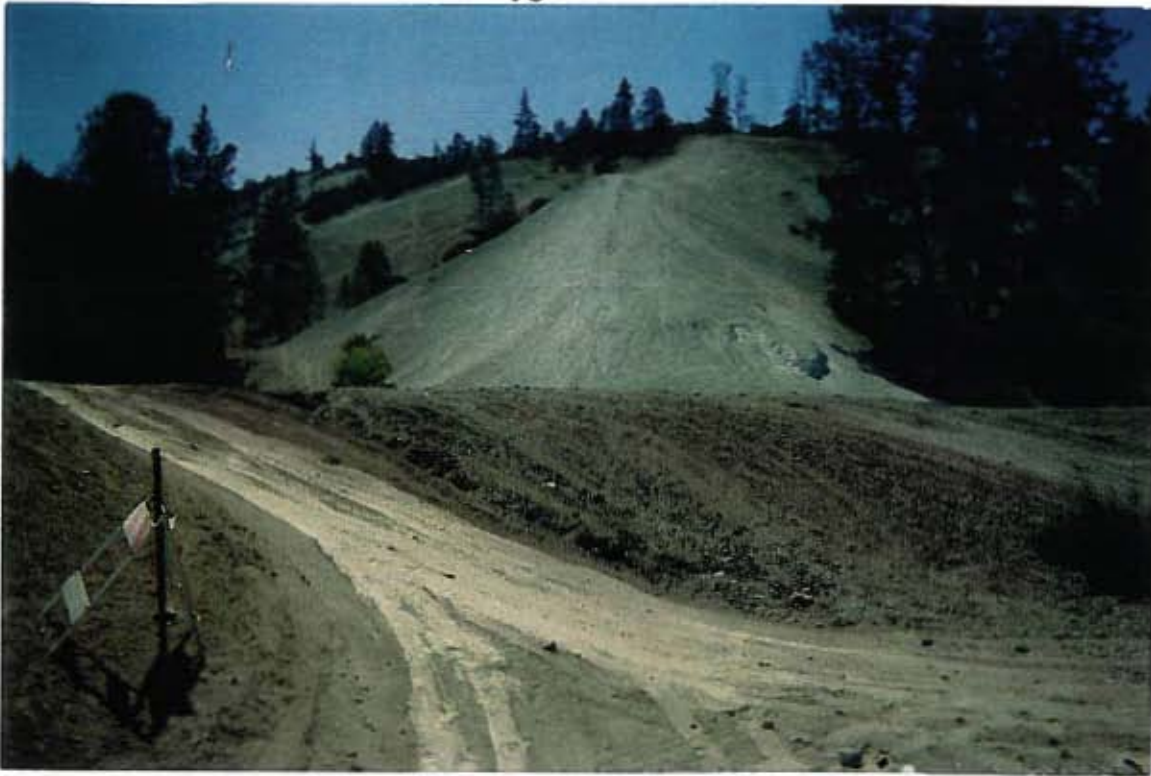
44) Looking SW from SC-1. Play area that has caused denuded soils on an interfluvial ridge line.

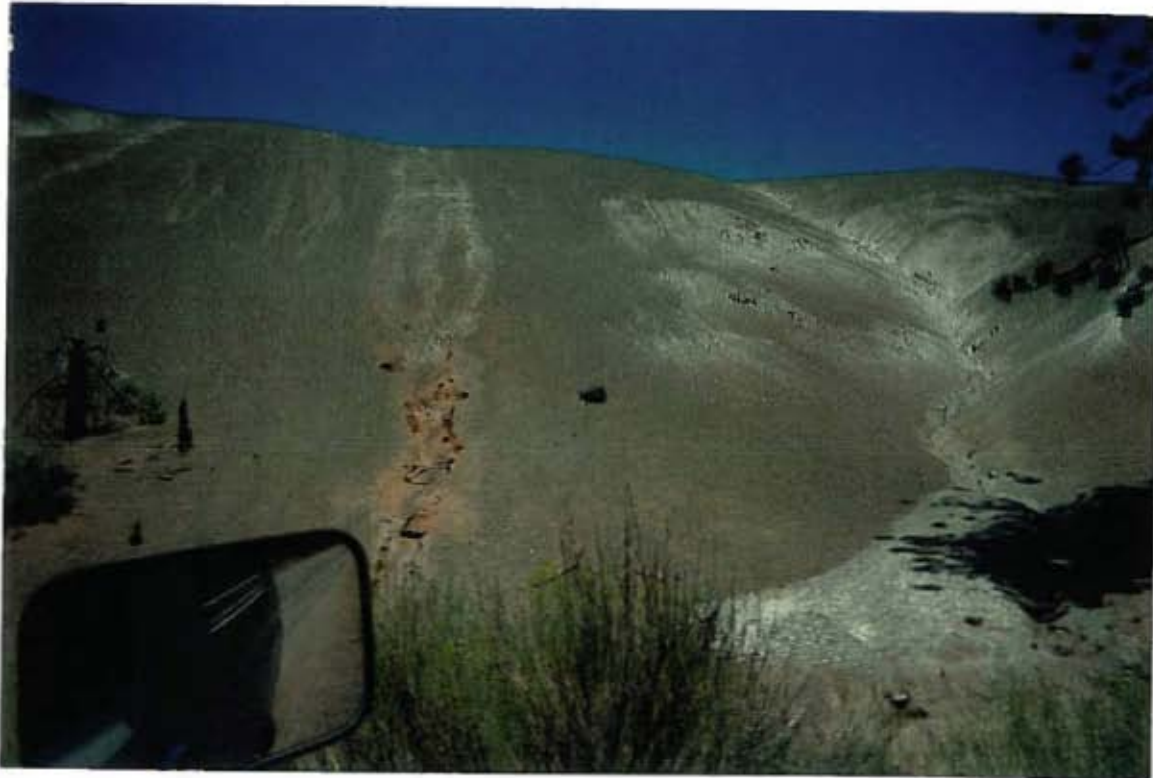
45) Looking N from SC-1. Well armored naturally gullied mid slopes, with sediment pile.

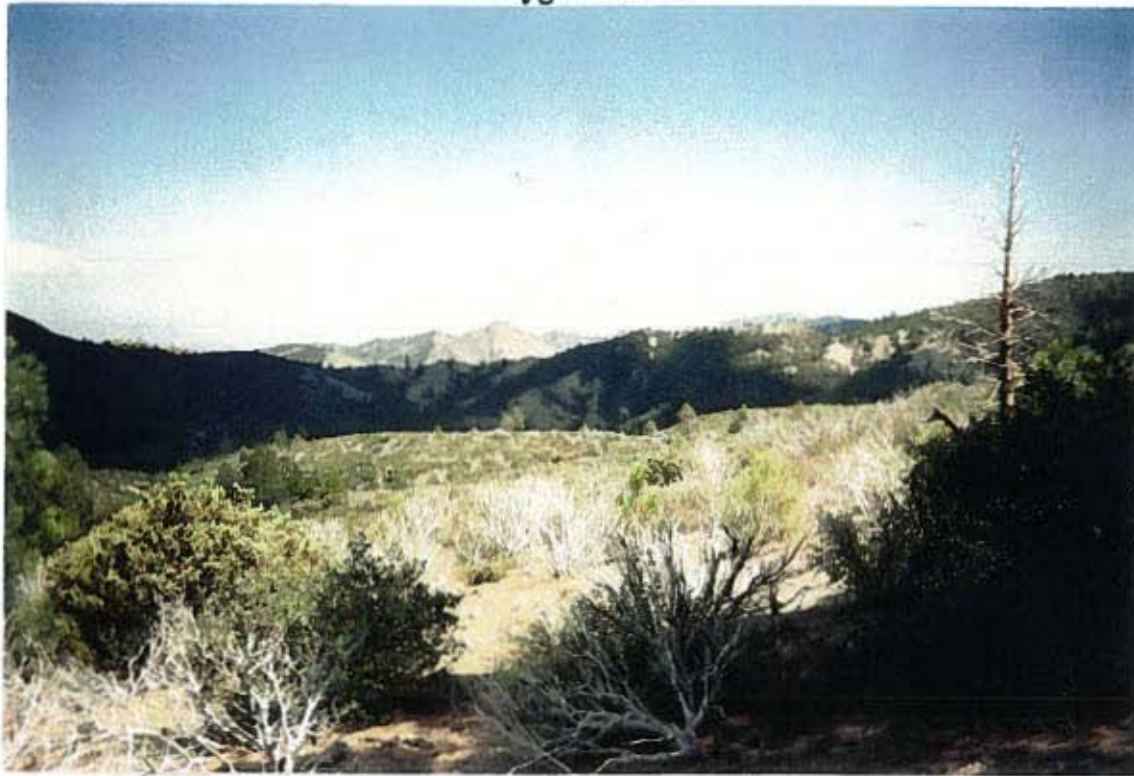
59) Looking NE from the CC-1A southern ridge. Isolated barrens surrounded by canopy buffer.

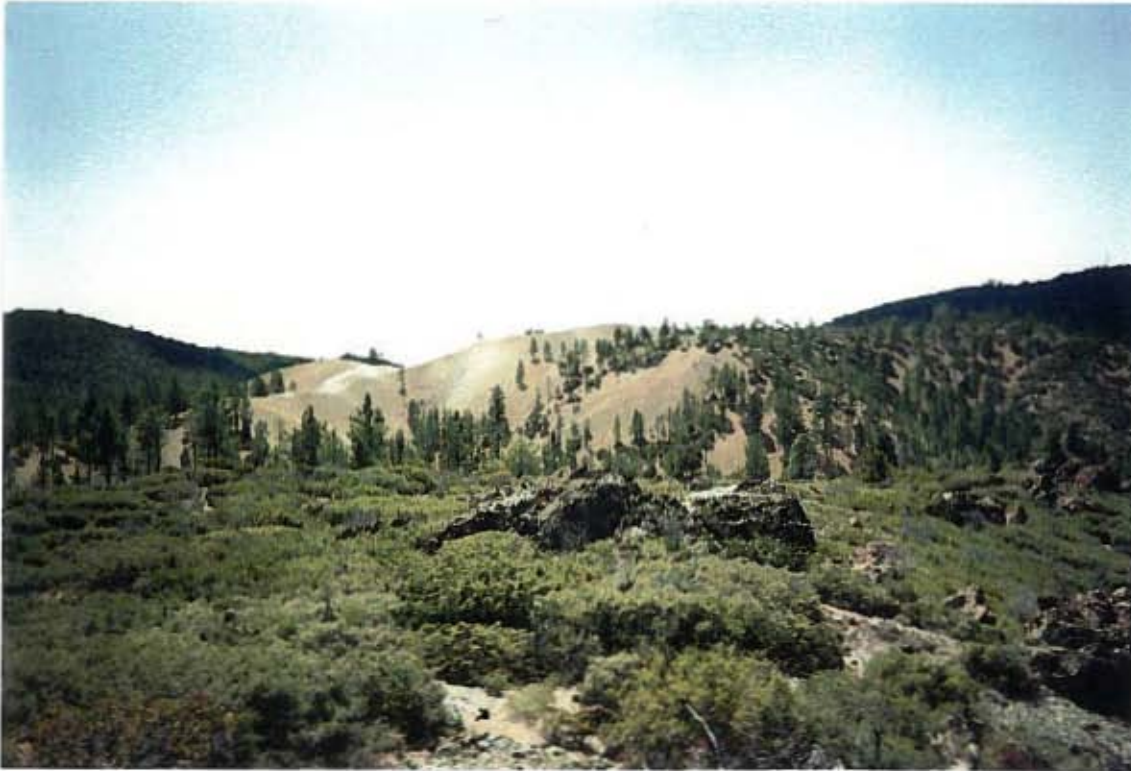
60) Looking W from CC-1B. Play area atop ridge line with canopy border.
